CUYAHOGA VALLEY NATIONAL PARK

Programmatic Environmental Assessment for Riverbank Management of the Cuyahoga River

4.0 AFFECTED ENVIRONMENT

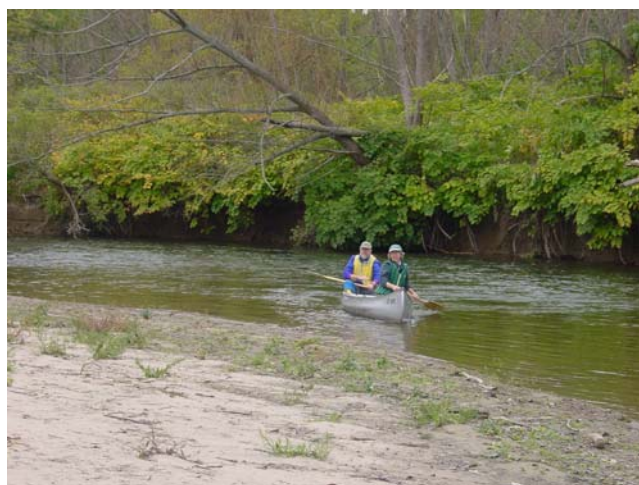
Japanese Knotweed above cut bank in Study Reach 4.

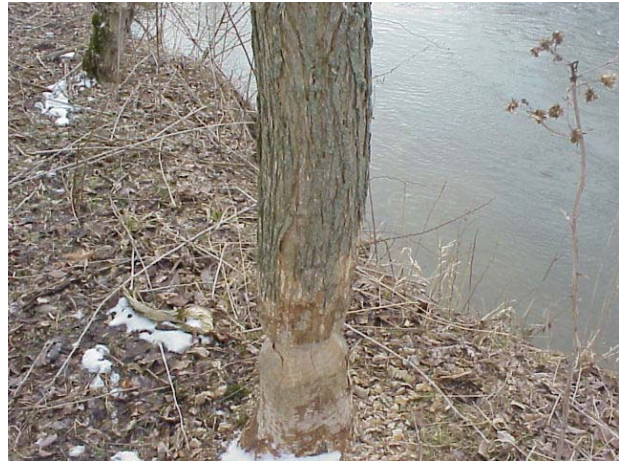
Evidence of beaver activity.

Although very little historical record is available, it is agreed that prior to European settlement, beaver (*Castor canadensis*) were abundant throughout Ohio (King, Bissel, Frank, 1979). However, by 1830, after many years of heavy trapping, beaver had been eliminated from Ohio. It was not until more than 100 years after they were extirpated from the state, that beaver reappeared in 1936 in the eastern counties of Ohio. Beaver probably moved into the Park area within the last ten years, and an initial inventory in 1991 found over 50 active or recently abandoned lodges. Through their dam-building and feeding activities, beaver act as a "Keystone" species, affecting ecosystem structure and dynamics far beyond their immediate requirements for food and cover. The wetlands which beaver construct and maintain for their own protection, also provide a range of habitats suitable for many plant and animal species. Any increase in beaver contributes to the increase of habitat for those species dependent upon wetlands. Decisions regarding the Riverbank Management Program for CVNP could affect and could be affected by beavers within the Park.
